NDE Methods for Certification and Production/Performance Monitoring of Composite Tanks

David McColskey, Marvin Hamstad
NIST-Boulder, CO

Regor Saulsberry, Jess Waller
NASA-JSC White Sands Test Facility

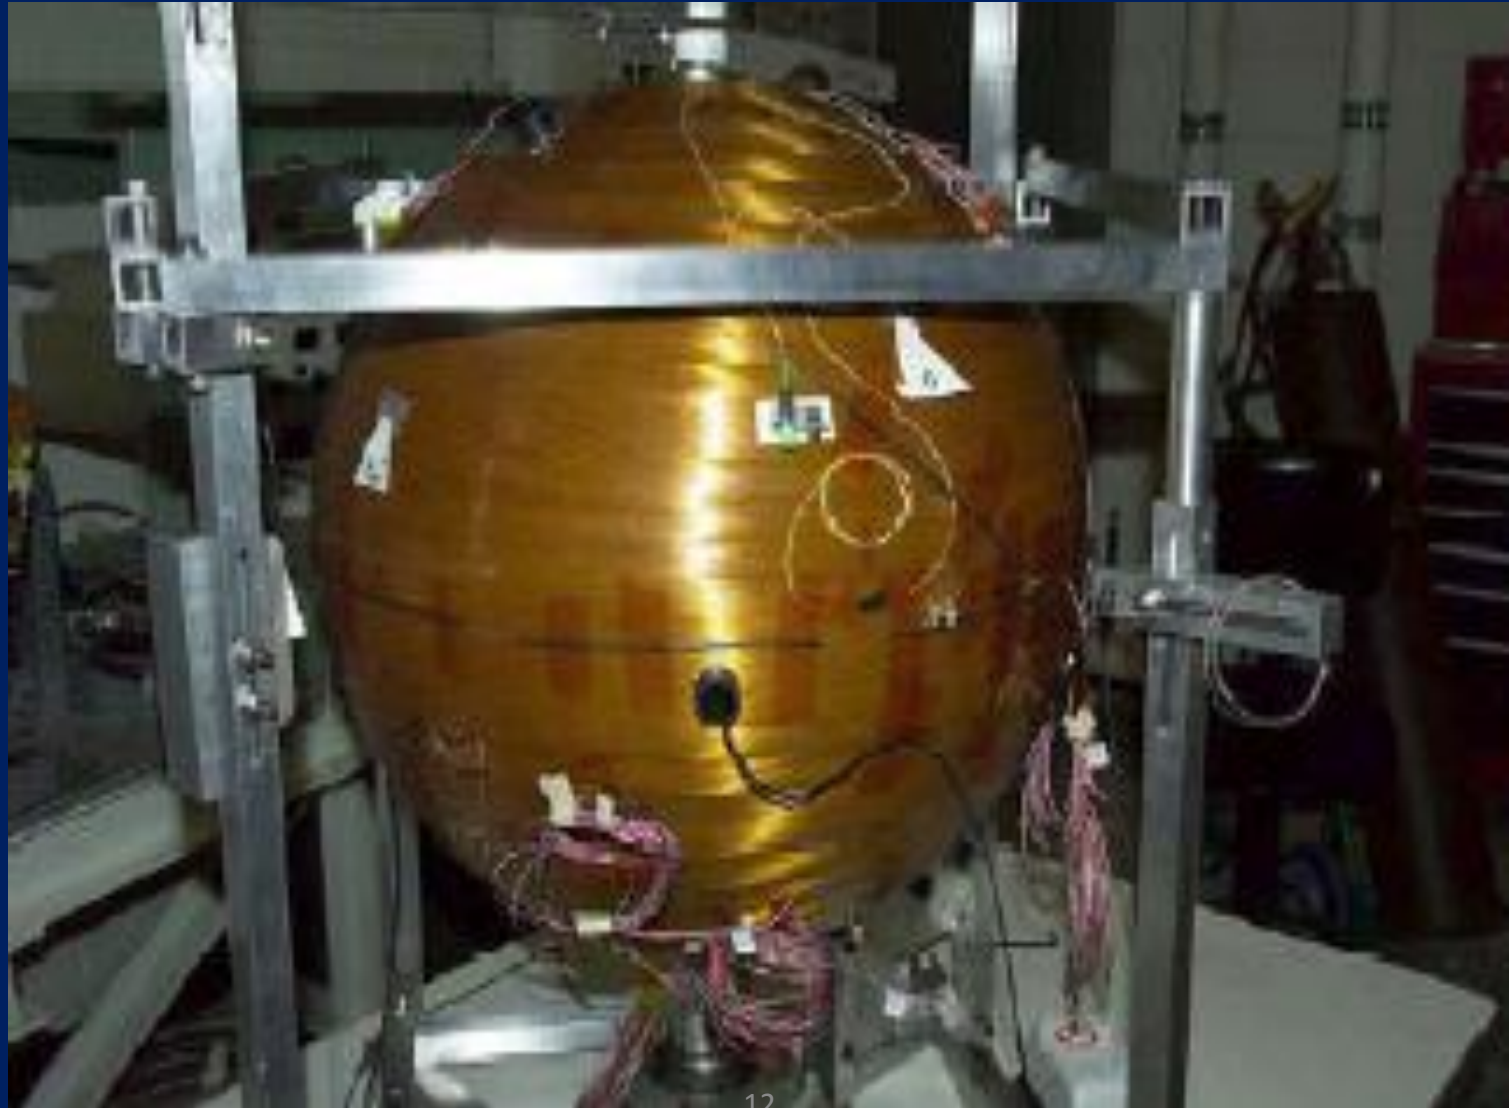
Orbiter Real-Time NDE

Method	Measurement
Visual Inspection (Pretest)	External inspection of overwrap. Indication of gross damage
Both Flash and Heat Soak Thermography (Pretest)	Heat Signature Decay Sub-surface Ply Delamination. Heat soak or thru transmission works better with thicker composites.
Videoscope Inspection (Pretest)	Internal inspection of liner. Indication of damage or buckling
Laser Profilometry	Internal surface mapping and measurement . Evaluate ripples, potential buckling, and crossover imprinting on spherical tanks
Laser Shearography	Differential strain resulting from any cause (e.g., impacts, delaminations, broken fiber, etc.)
Cabled Girth and Boss LVDT	Circumferential and axial displacement
Strain Gauge (Test)	Change in length. Average fiber strain under the sensor.
Fiber Bragg Grating (Test)	Change in length. More localized strain
Acoustic Emission (Test)	Acoustic noise. Fiber breakage or delamination.

Full Field Digital Image Correlation	Global or localized strain
Eddy Current Probes	Composite thickness change
Portable Raman Spectroscopy	Residual stress/identification of stress gradients. May have potential to indicate stress rupture progression (S/N 007)

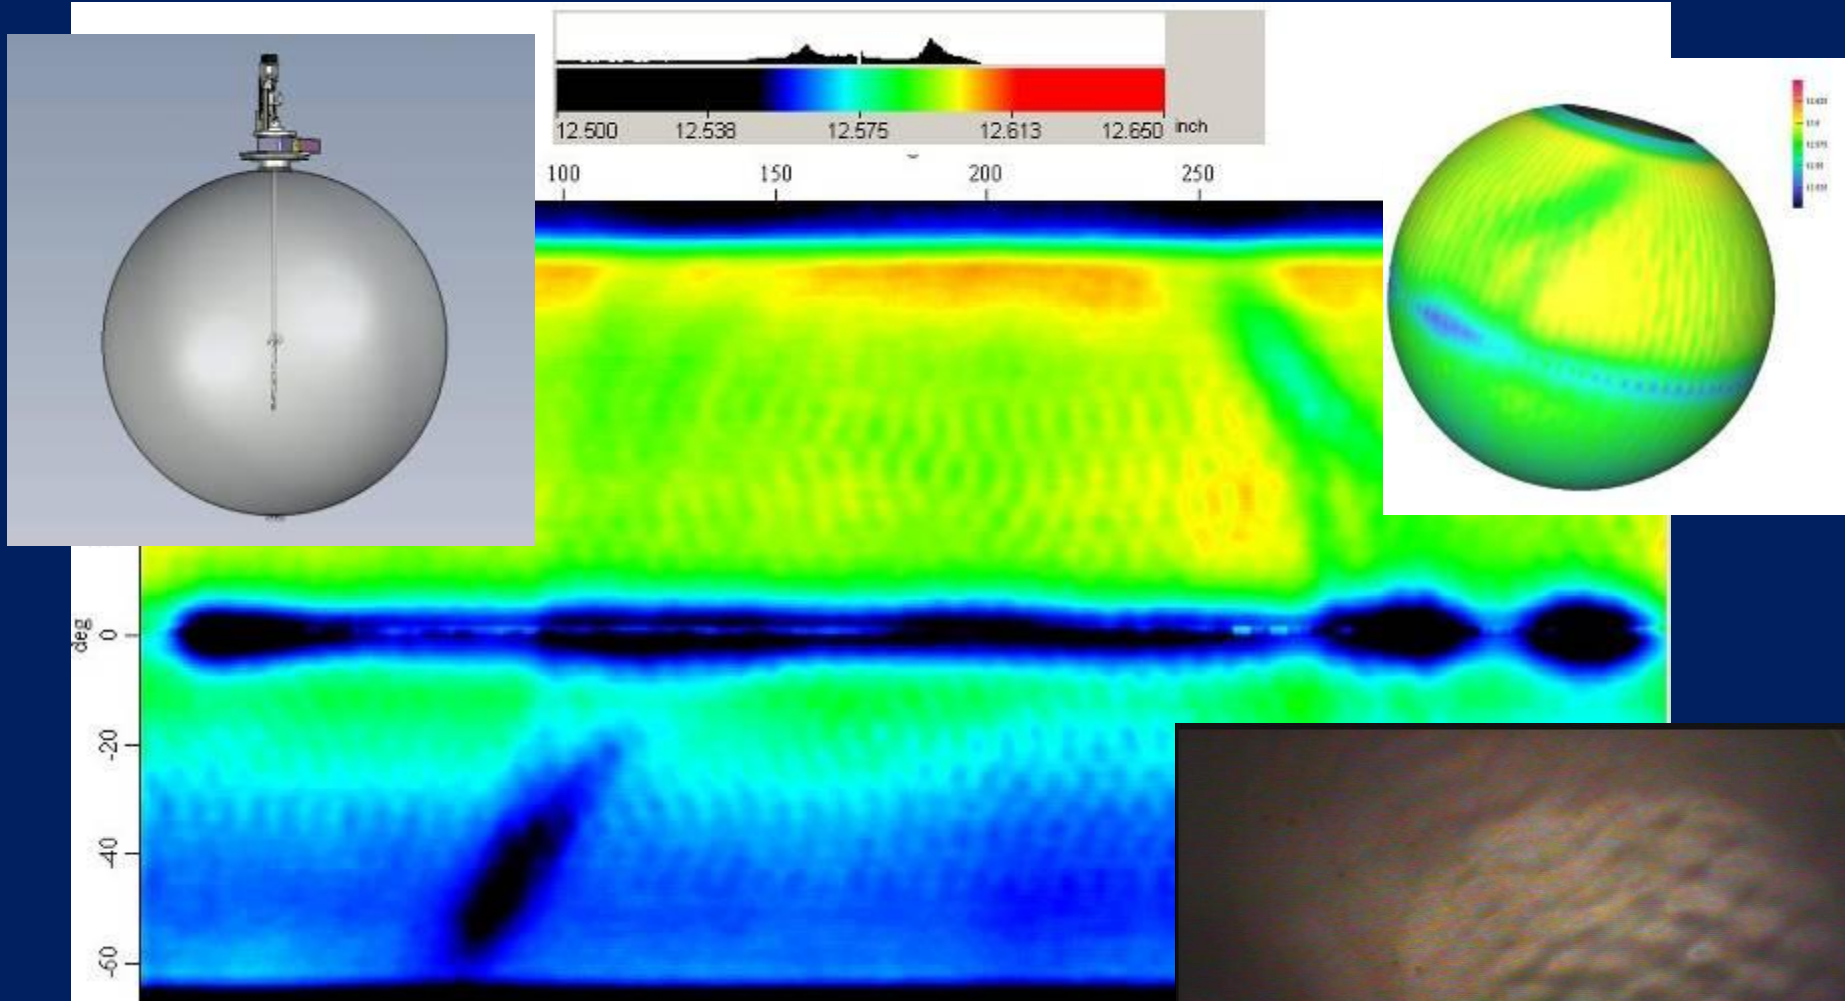
Laser Profilometry Accurately Quantifies Liner Buckling and Other Surface Features

Calibration traceable to National Standard and demonstrated 0.001 in. accuracy/repeatability on 26-in. and better than 0.002 in. accuracy/ repeatability on 40-in.

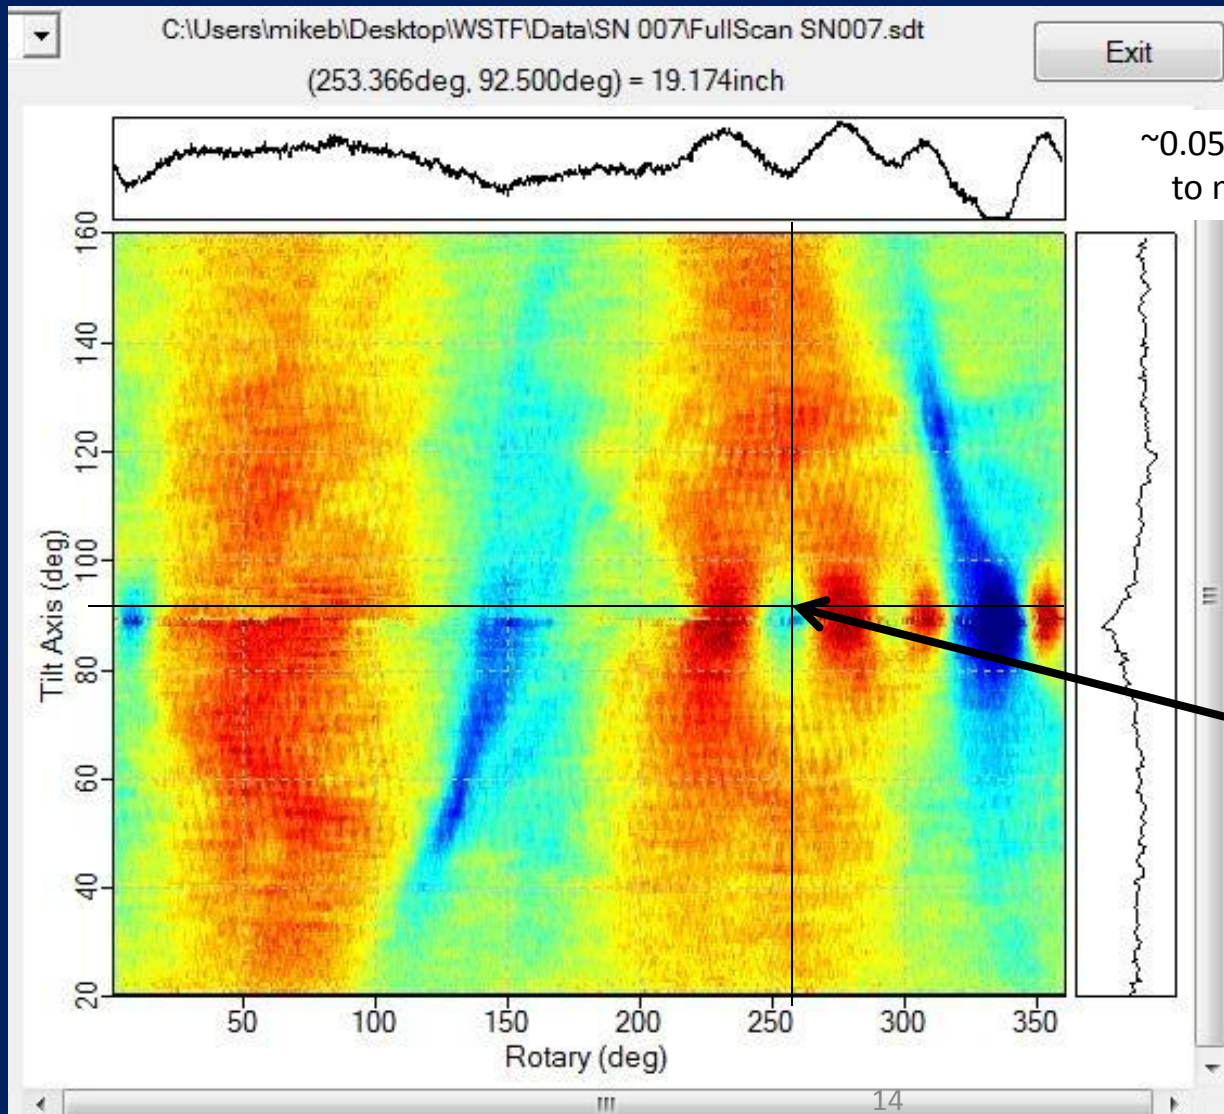
Profilometry of S/N 007 (cont'd)

~0.050 in. min.
to max.

0.040 in. range

Profile just above weld

- The large ripples around the girth weld raised a question, but no other observed indications were an issue with planned stress rupture testing
 - Eddy current sensors were placed over the peak of each girth ripple and monitored during pressurization to verify the liner did not flex causing a metallic fatigue concern
 - Decrease of stand-off between the fixed composite surface and liner ripple would indicate a liner buckle and associated air pocket
 - Stand-off remained fixed during pressure cycles, indicating that the indications were not a concern

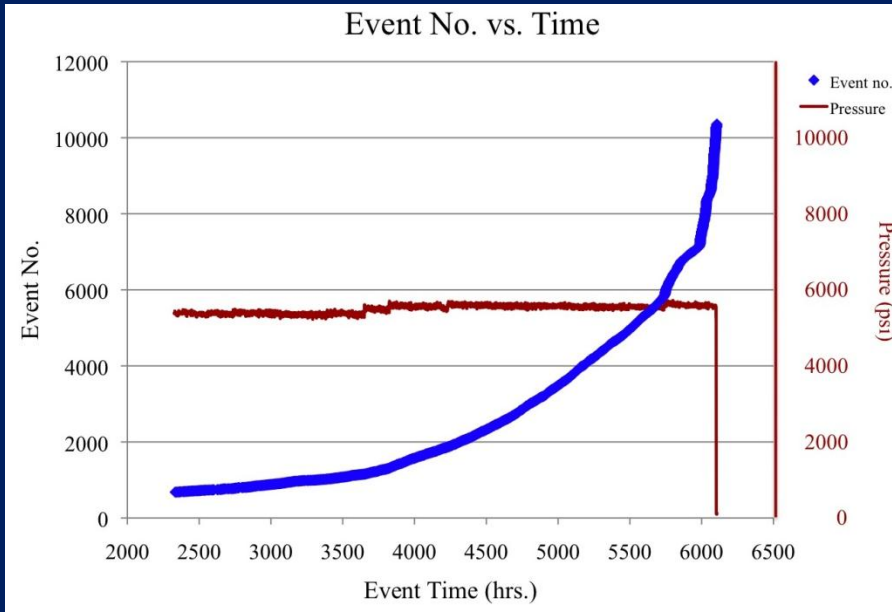
AE Effective in Monitoring Orbiter 40-in. Vessel Stress Rupture Progression to Failure

- There were two AE event rate increase periods that occurred during the last 7 days. The last rate increase ended in failure.
 - There were over 3000 recorded events during the last 10 days.

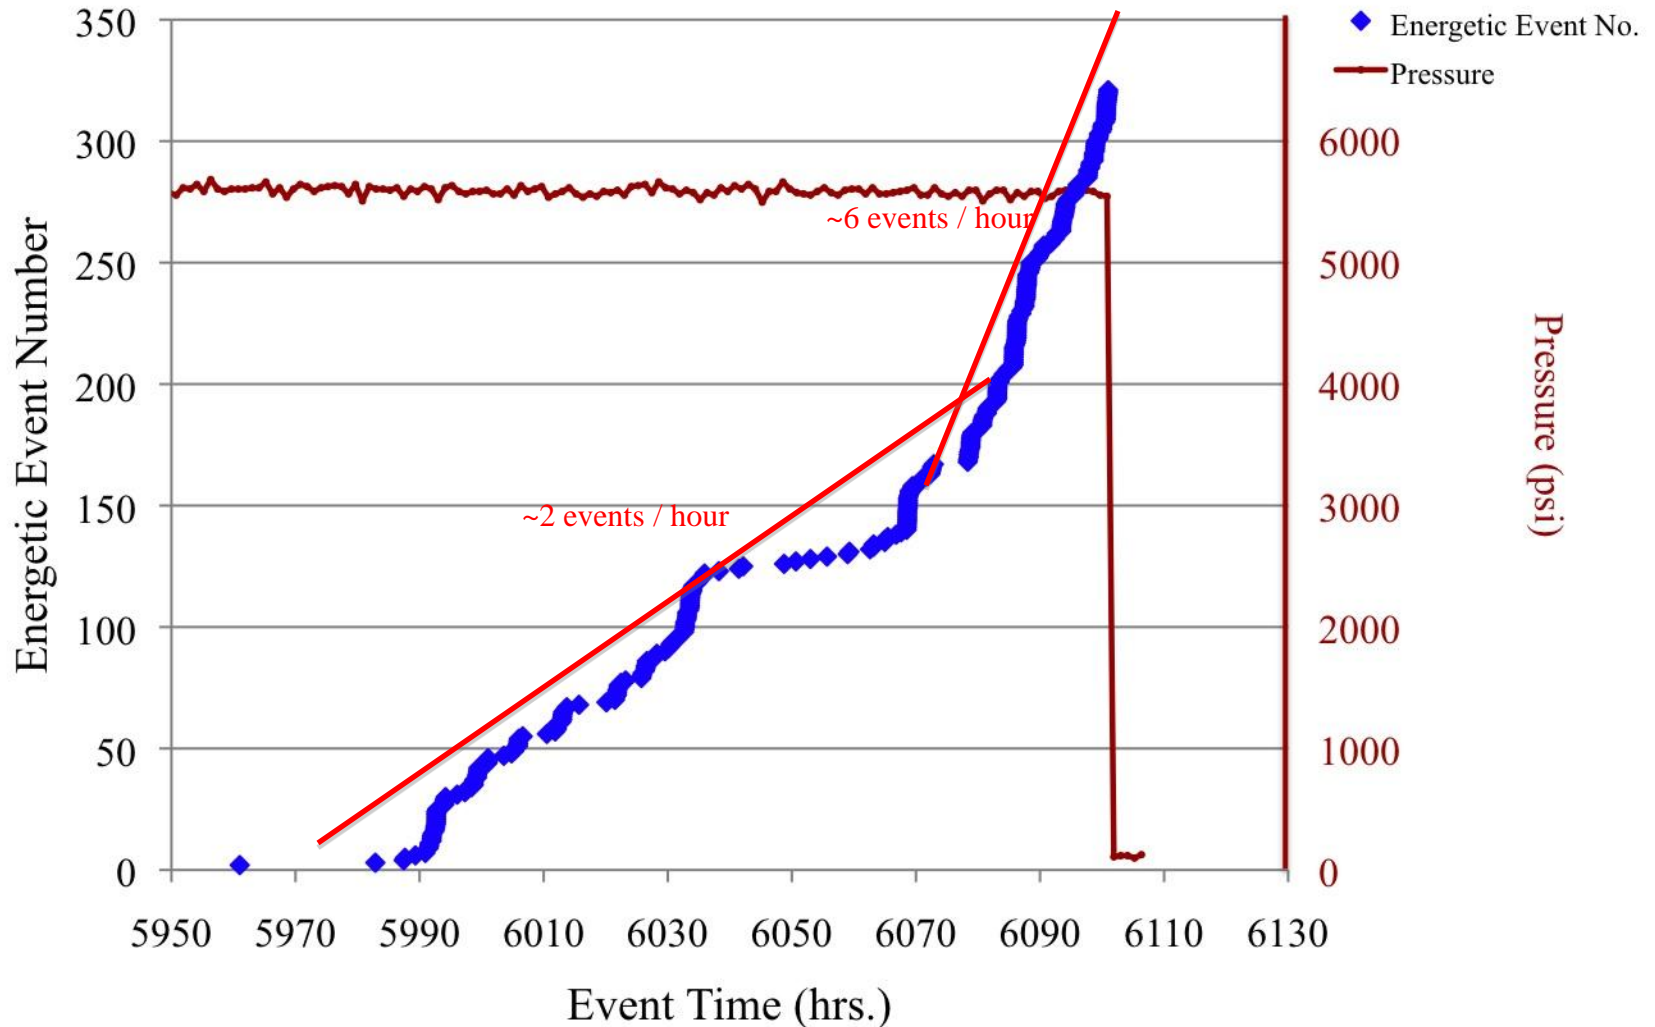
Energetic Event No. vs. Time: Final Week

- There were more than 300 very energetic events recorded during the last week.
 - The rate increases were coincidental with trains of very large energy signal events.

- The first rate increase for large energy, signal events (24 to 96 hours before the end) was approximately 2/hour.
 - The second and final rate increase for large energy signal events (last 24 hours) was approximately 6/hour.

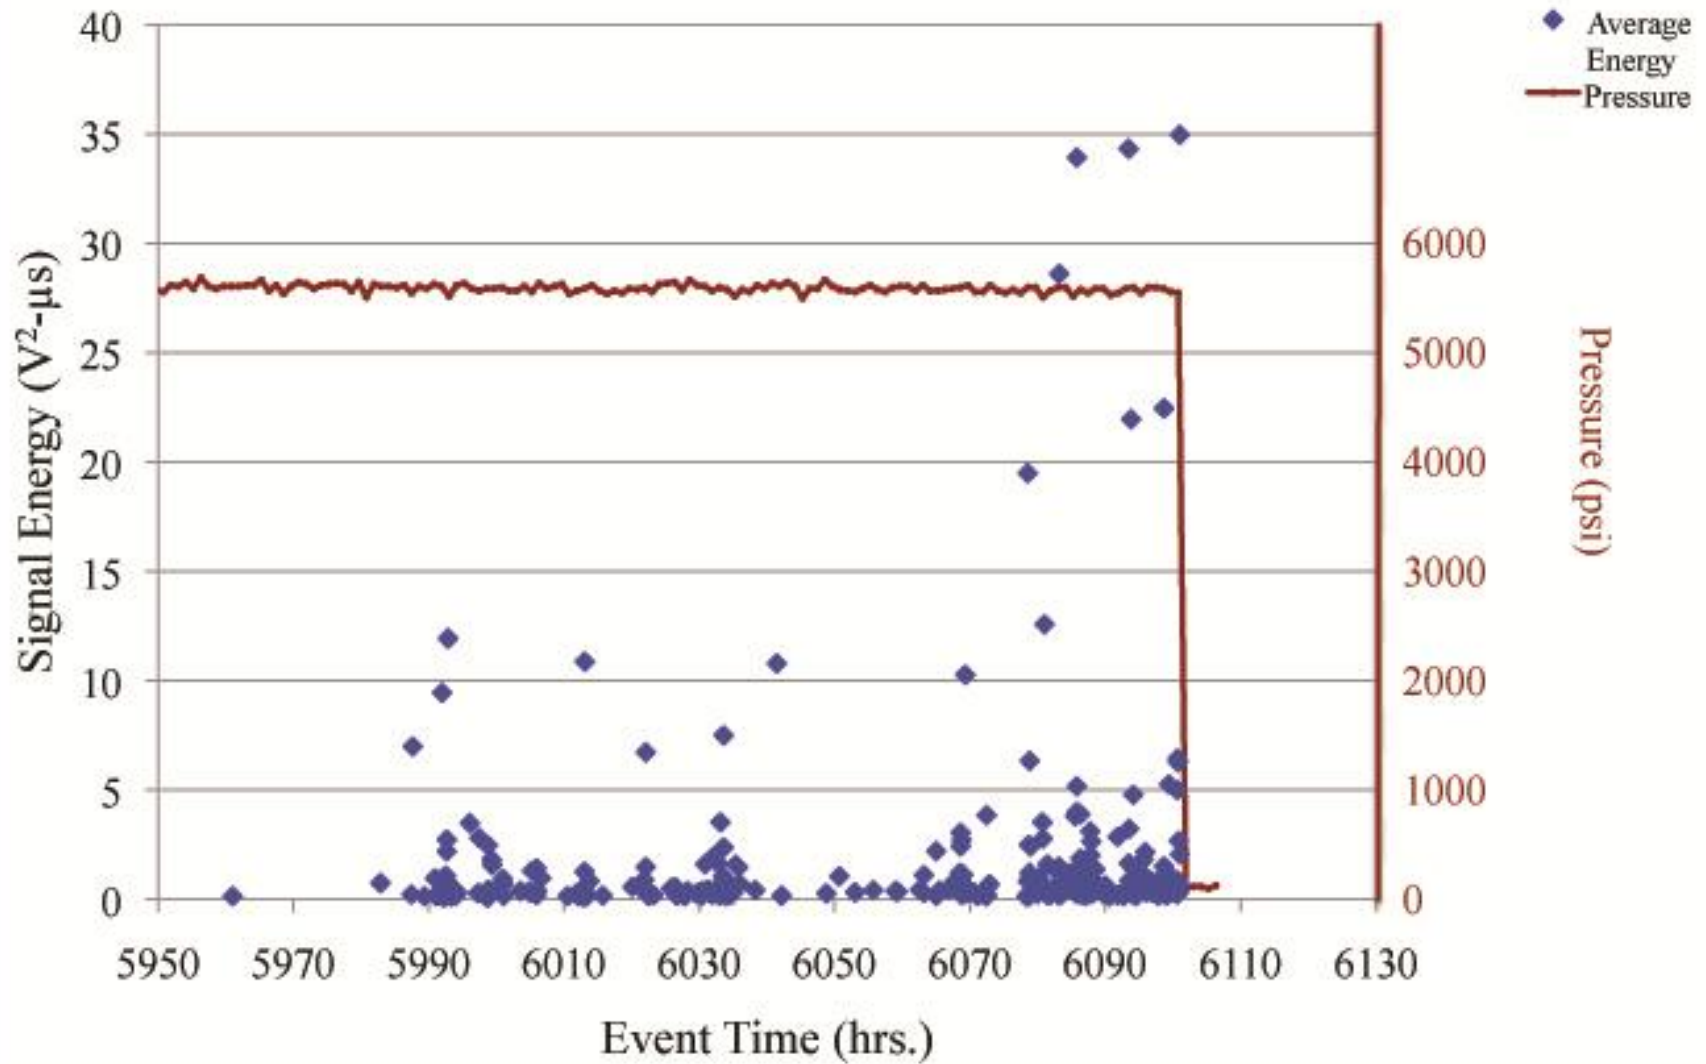
Energetic Signal Levels vs. Time: Final Week

- Event energies rose to very elevated levels during the last 96 hours.
 - High energy events were > 25 times greater than energetic events in the past.

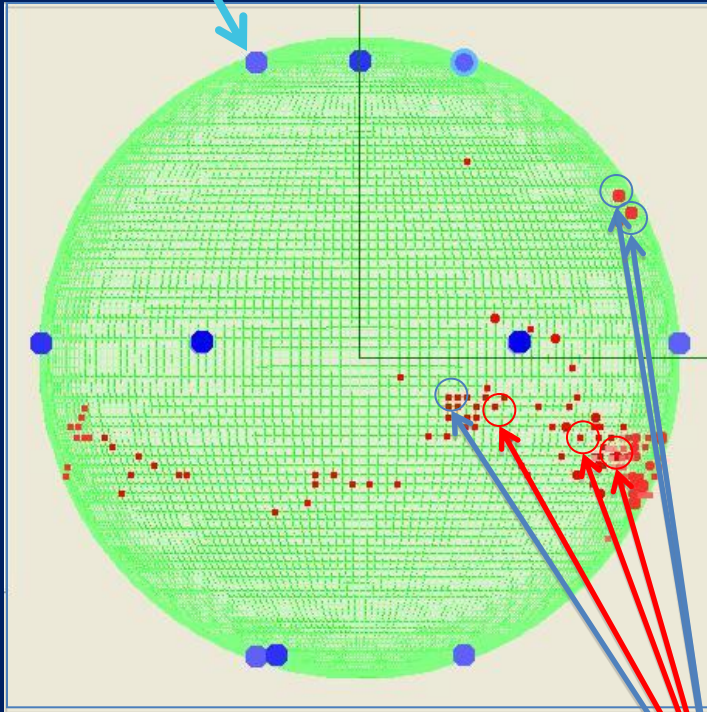
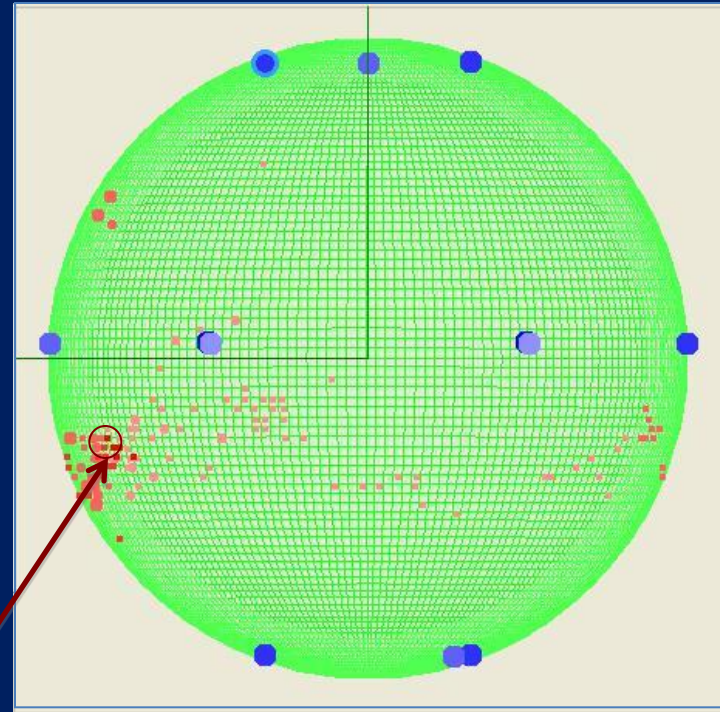
-90° view—Back side view

90° view—Front side view

Locations of Energetic Events

Red lines are the location of the larger events

The dark red line is the location at depressurization (which was the largest)

- The loudest events occurred at the end (last 24 hours).
 - The final event, which was the loudest, was located $\sim 45^\circ$ below the equator and near the azimuth angle of 45° .

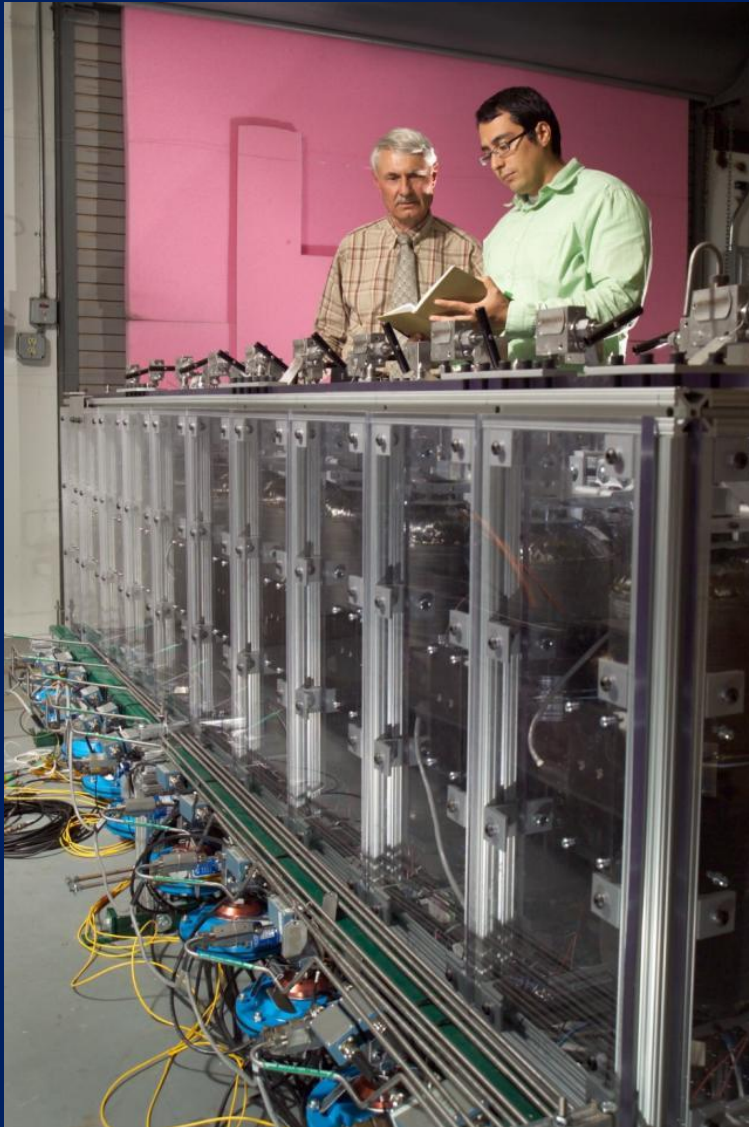
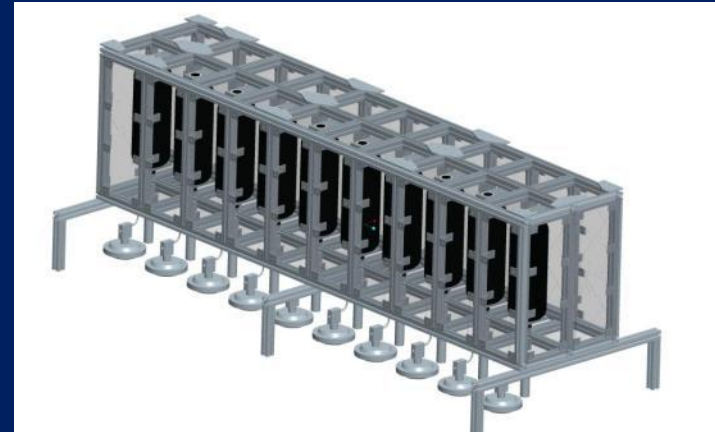
20 carbon vessels and real-time NDE in WSTF Lexan protective enclosure allows inspection while at test pressure

- T1000 and IM7 strand tensile tests and stress rupture completed at Cornell University and WSTF to ensure lot consistency and help set test pressures
- State-of-the-art 20 station test system brought on-line
 - Maintains hold pressure at approximately ± 2 psi regardless of temperature swings (appears to be a first for the Stress Rupture test industry)
 - Rapidly auto-isolates bottles as they rupture
 - Protective enclosures allow inspection of vessels up to rupture pressure
 - Extensive data acquisition and real-time NDE capability to validate sensors and NDE

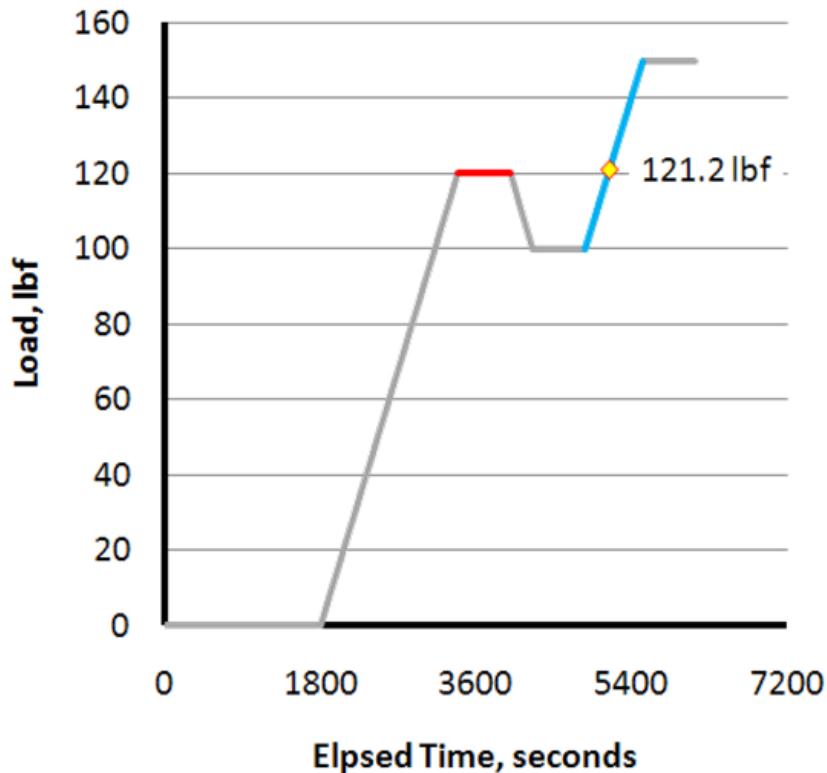
Example using an intermittent load hold (ILH) profile:

- Load Profile
- Previous Max Load Plateau
- Loading Phase
- ◆ First Significant AE (loading)

$$FR = \frac{121.2}{120} = 1.01$$

Felicity ratio (FR) given by:

$$FR = \frac{\text{stress at onset of significant acoustic emission during loading}}{\text{maximum previous stress plateau}}$$

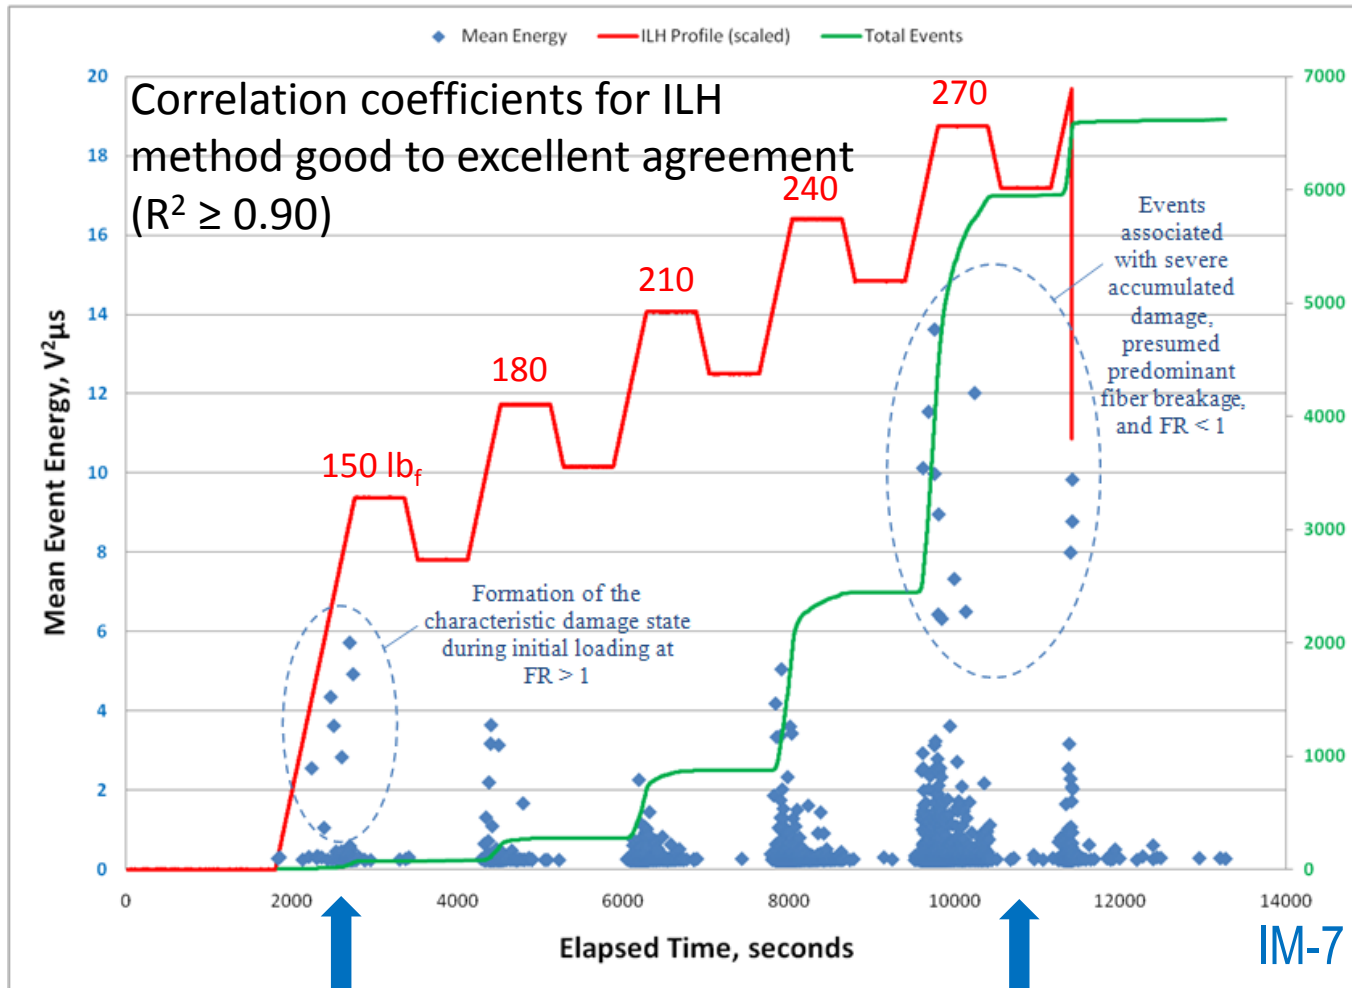
Regions of high AE activity correspond to events occurring early in COPV life cycle up to catastrophic failure

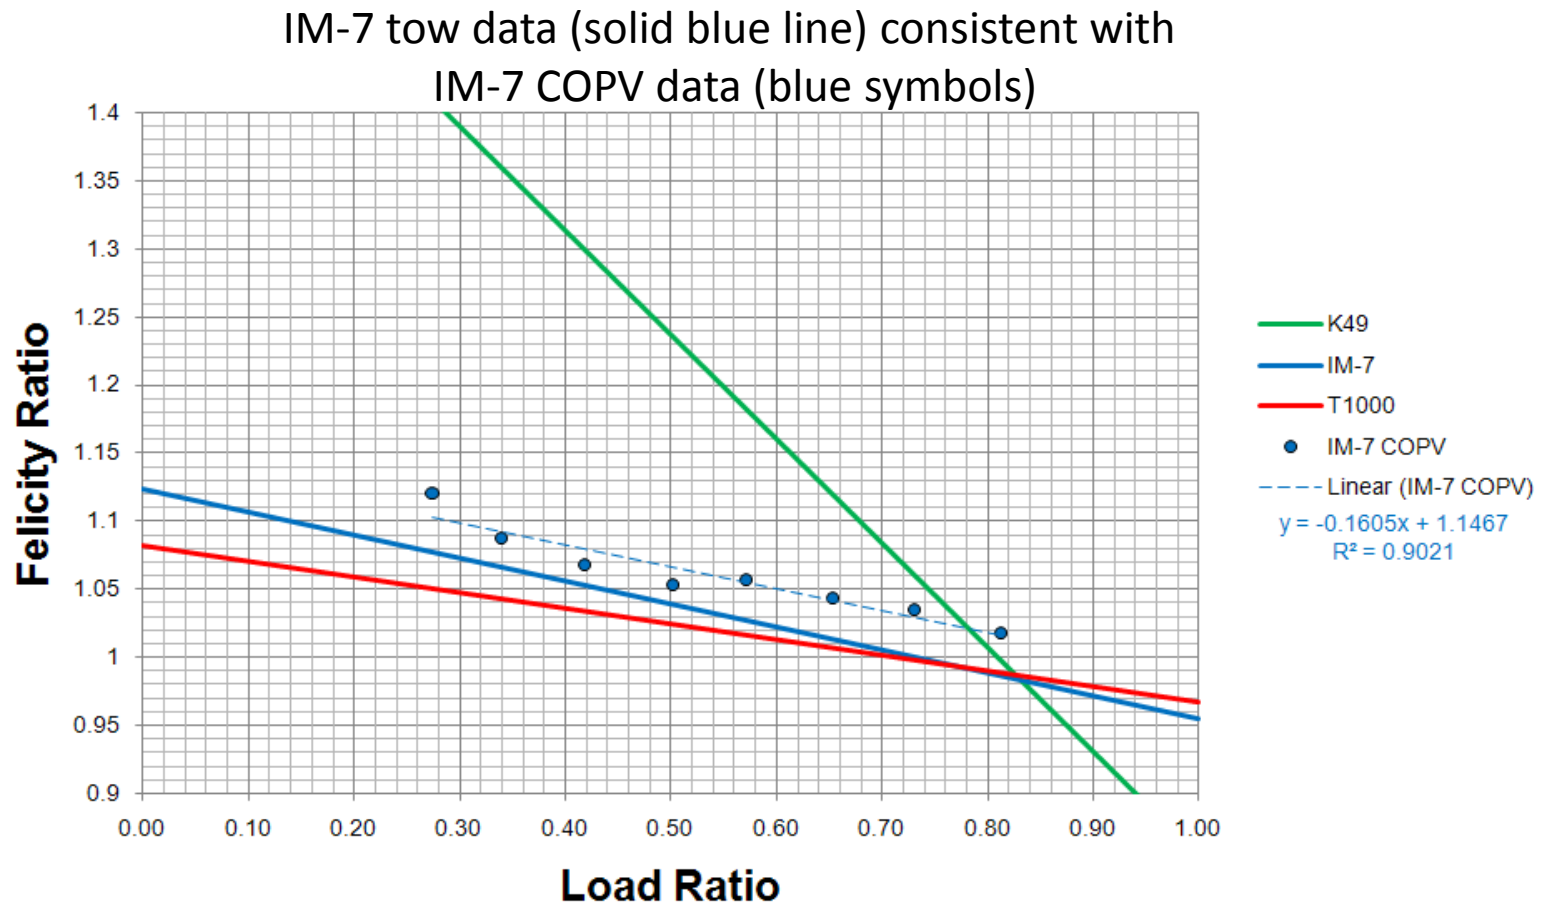
Correlation of IM7 C/Ep COPV AE Felicity Ratio to Strand Data

Proof-of-concept Felicity ratio analysis of an IM-7 reinforced C/Ep COPV (blue dots) superimposed on Kevlar[®] 49 (green line), T1000 (red line), and IM7 (blue line) single tow data

FR and Shelby Ratio (SR) show some promise of predictability of stress-rupture “when related to damage-site monitoring”

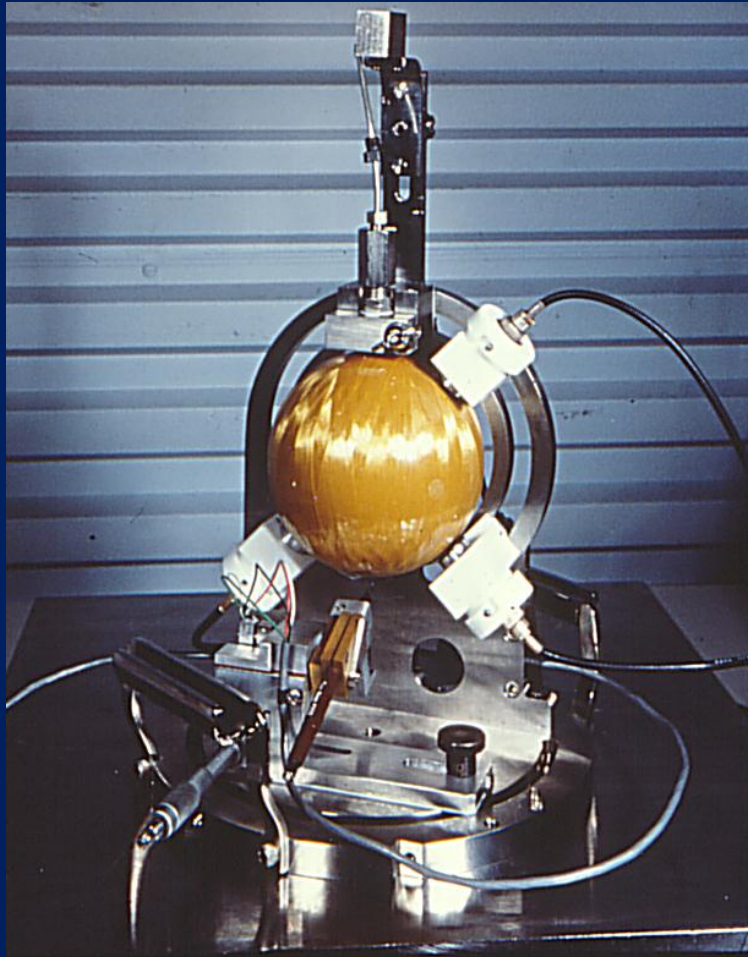
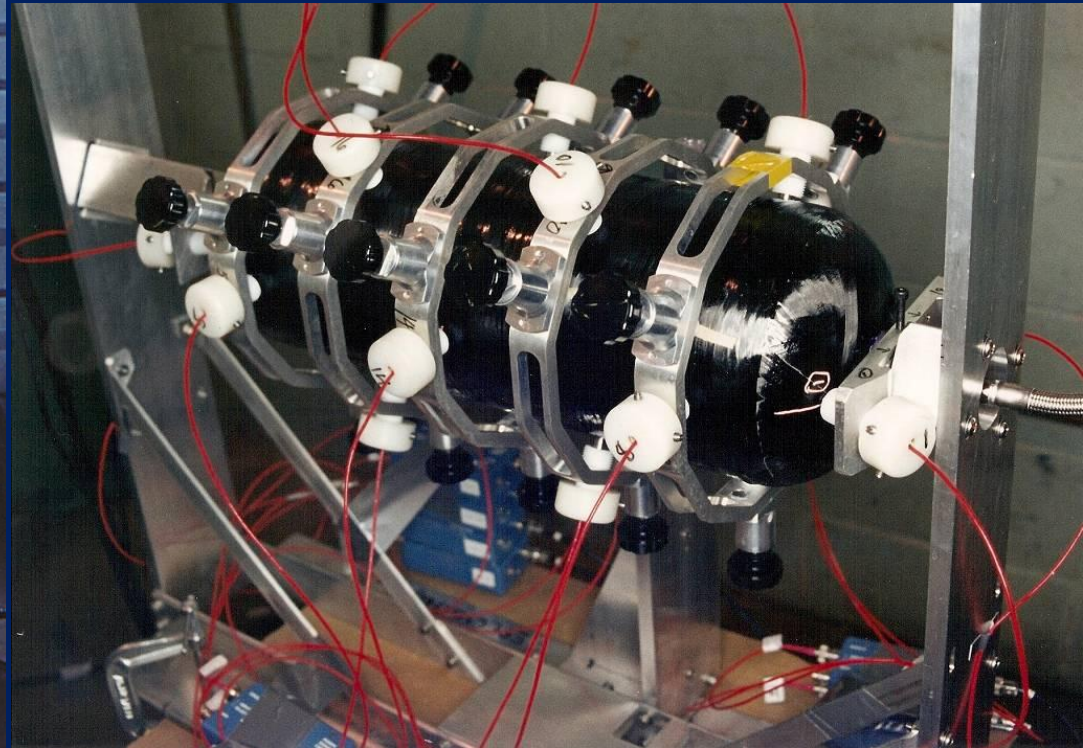
Test fixture for Kevlar/epoxy COPV proof testing with AE and for Carbon/epoxy proof testing

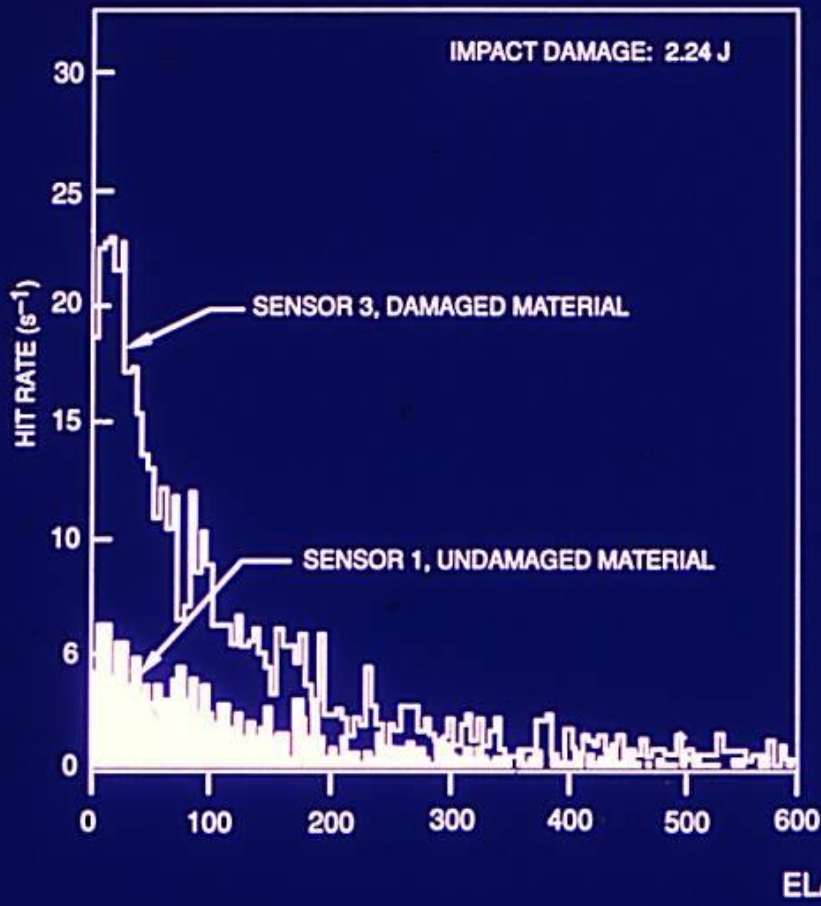
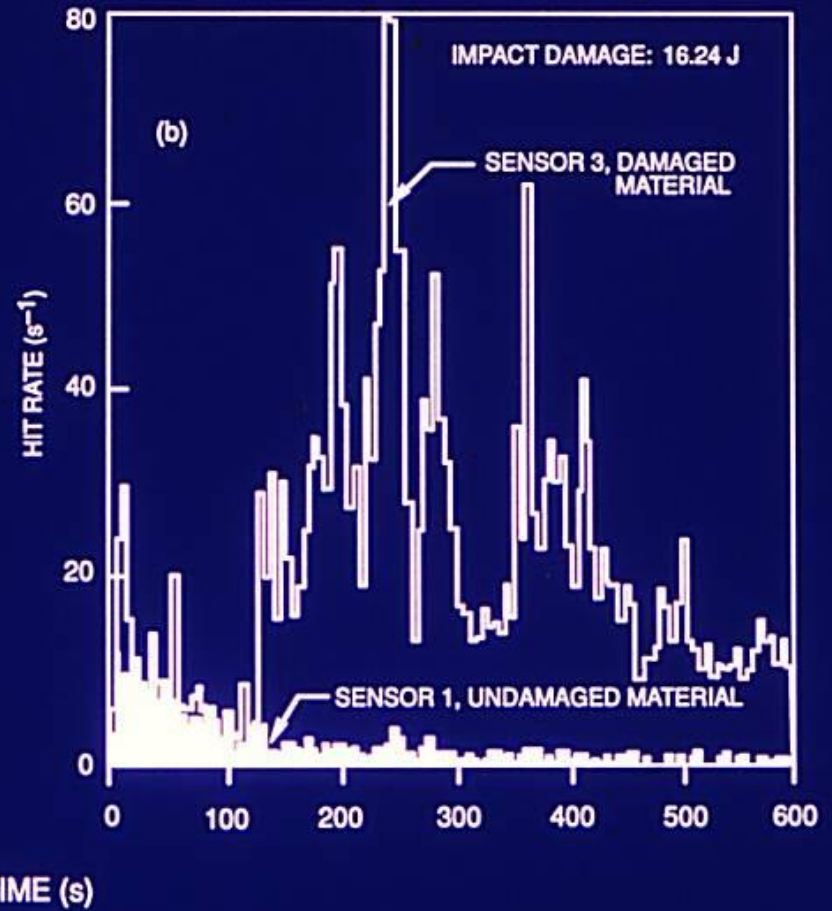
AE during a static hold pressure varied with the time, location and degree of impact damage of Kevlar/epoxy pressure vessels

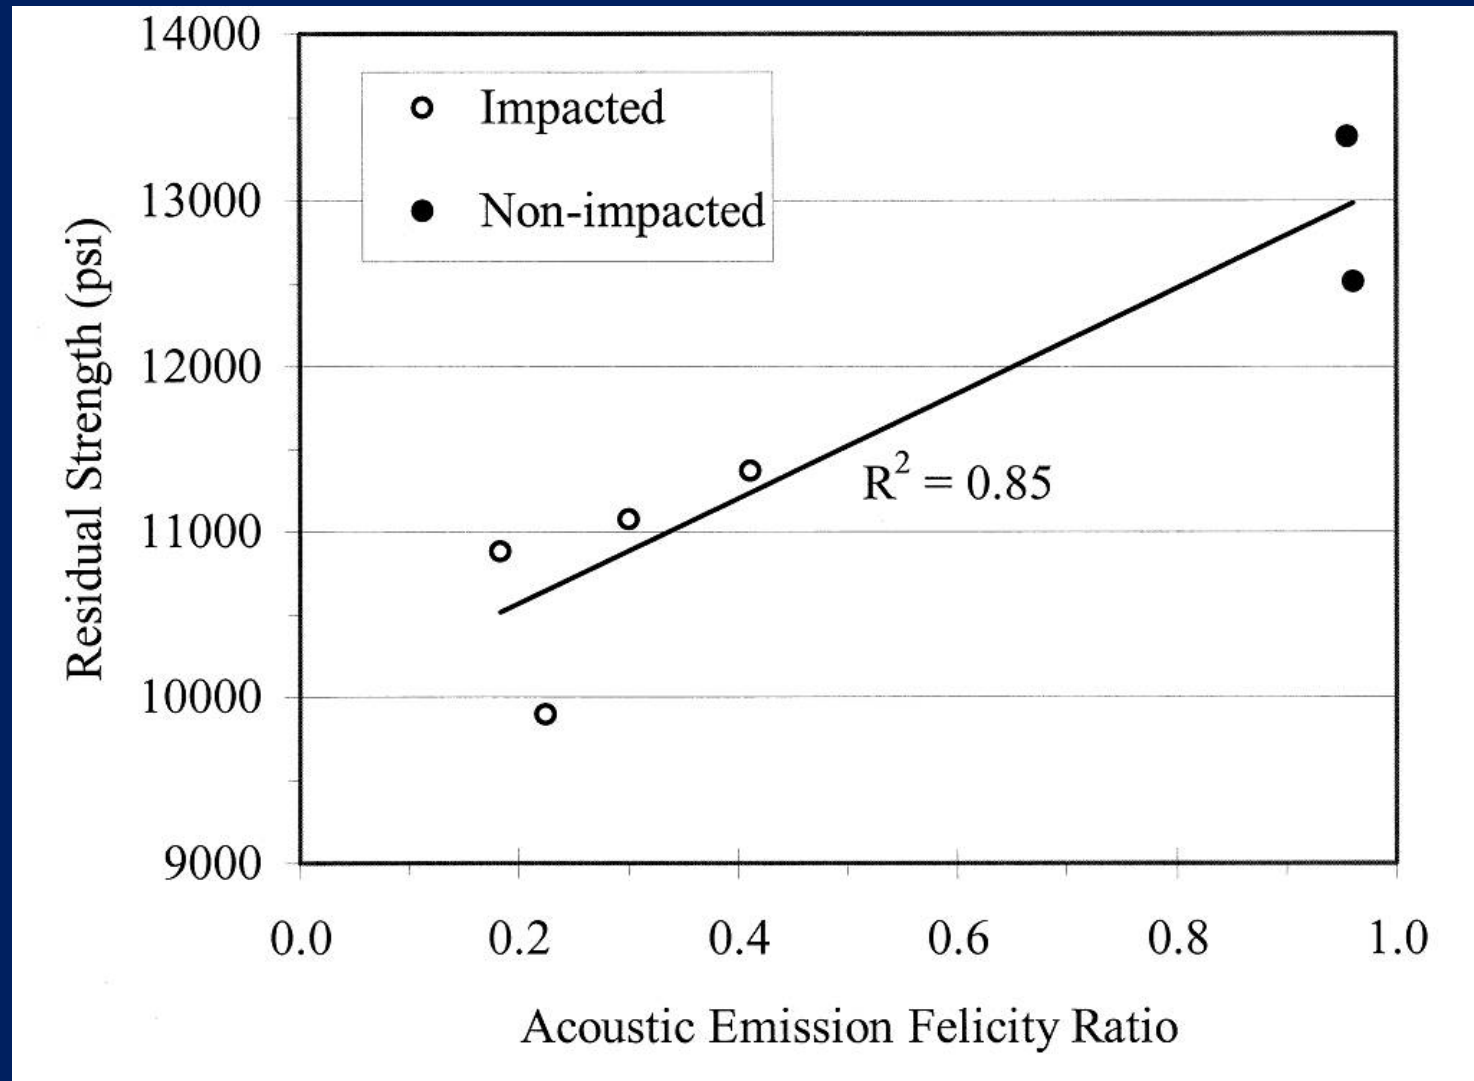
AE from the second pressurization (to the proof level) of a cylindrical carbon/epoxy pressure vessel correlates with the residual strength, if AE from the region of the impact (eventual failure location) is considered

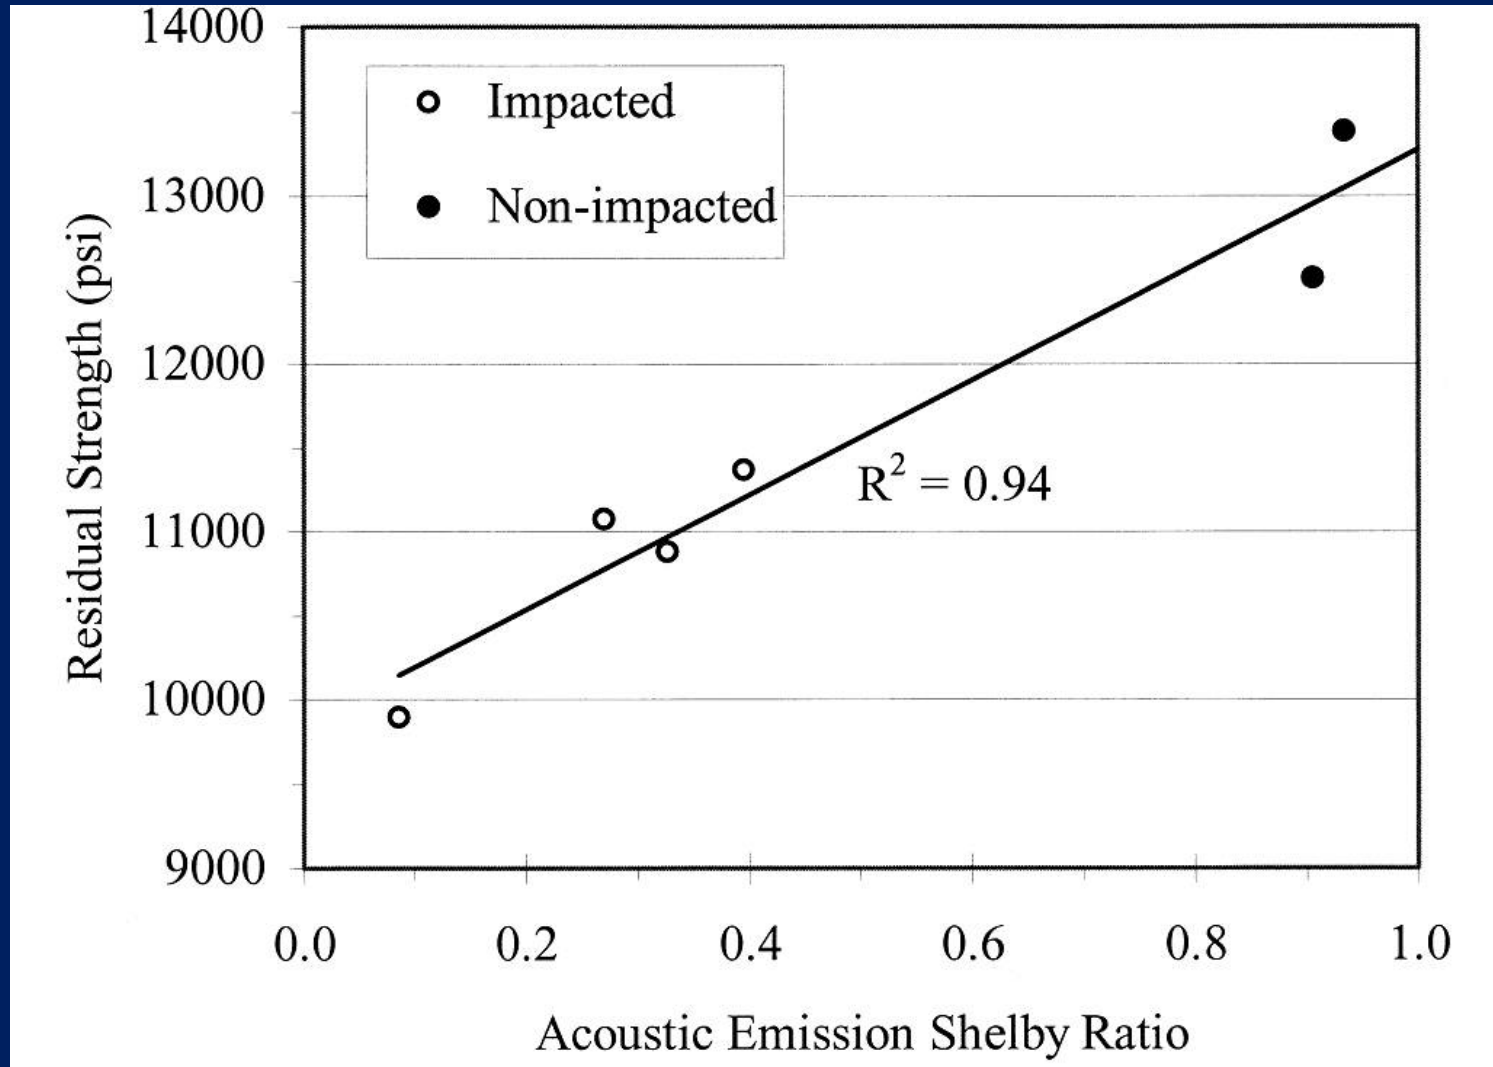
AE from the second de-pressurization (from proof level) of a cylindrical carbon/epoxy pressure vessel correlates with the residual strength, if AE from the region of the impact (eventual failure location) is considered
