NDE Methods for Certification and Production/Performance Monitoring of Composite Tanks

David McColskey, Marvin Hamstad
NIST-Boulder, CO

Regor Saulsberry, Jess Waller
NASA-JSC White Sands Test Facility

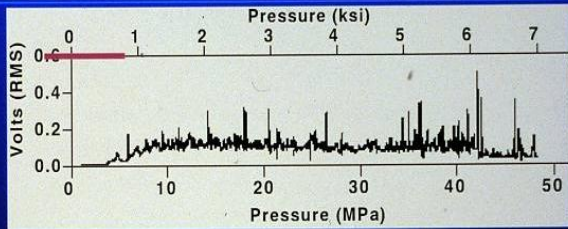
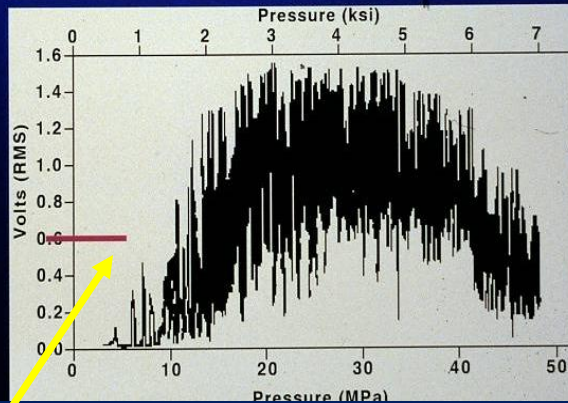
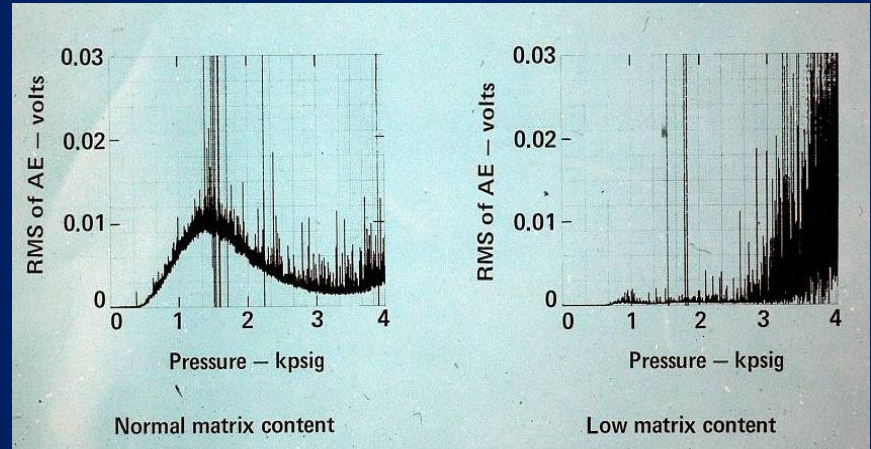
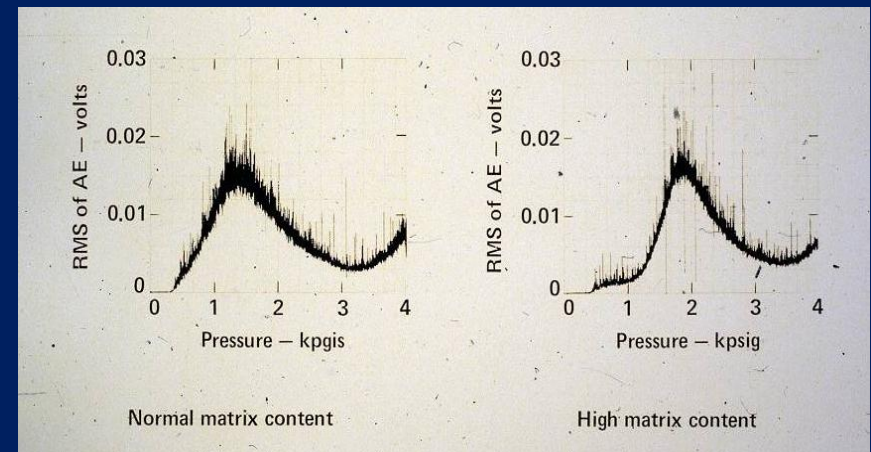
AE signatures versus pressure during the virgin pressurization (autofrettage or proof test) of COPVs can indicate whether composite has been filament wound correctly

Low Resin Content

High Resin Content

Same level as full scale in top figure

Cases of low and high matrix content
